# Manhole Inspection Summary

Manhole # S69M\_\_018MH

Insp Date: **2/1/08 9:09 AM**

**Location** Address: **1124 Dundalk Ave.**

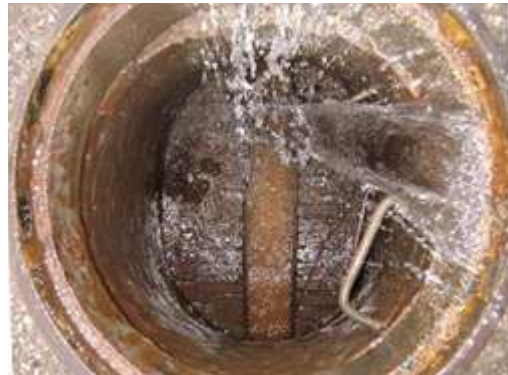
Top View

Comments **WATER IN TOP VIEW IS FROM SURFACE WATER FLOWING INTO THE OPEN MANHOLE.**

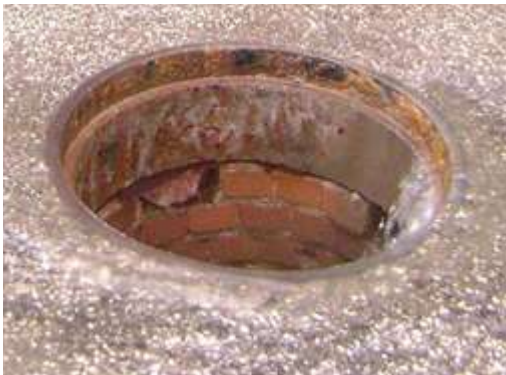
Defect 1

Condition: ☐ Sound ☐ Cracked ☐ Root Intrusion ☒ **Loose Brick** ☒ **Deteriorated**

Infiltration: ☐ None ☒ **Joint** ☐ Cracks ☒ **Mortar** ☐ Roots ☐ Wall

Loose bricks in chimney

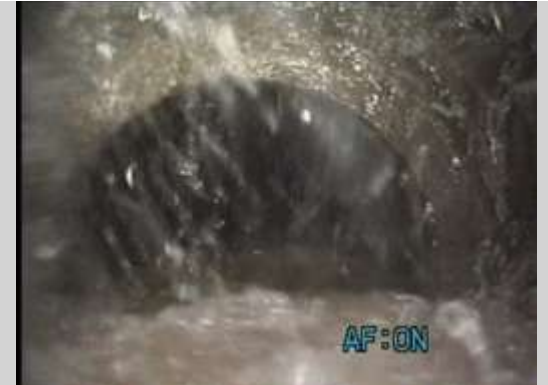
12 O'Clock Outflow

8 in. Circular Gravity Sewer  
Pipe Out @ 12 O'Clock

Pipe Height: **8.4** (in.) Rod and Bar (Angled)  
Pipe Material: **Clay** ☐ Pipe Lined  
Invert Depth: **8.25** (ft.) Flow Characteristics: **Fast**  
Deposits: ☒ None ☐ Mud ☐ Sludge ☐ Debris ☐ Grease  
Silt Depth: (in.) Deposits Extent:  
Infiltration: **None** Pipe Seal Cond: **Sound**

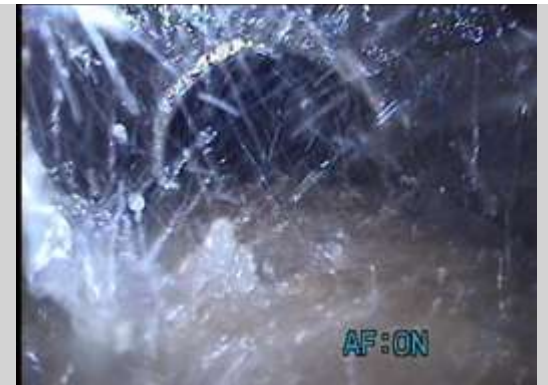
6 O'Clock Inflow

8 in. Circular Gravity Sewer  
Pipe In @ 6 O'Clock

Pipe Height: **8.4** (in.) Rod and Bar (Angled)  
Pipe Material: **Clay** ☐ Pipe Lined  
Invert Depth: **8.17** (ft.) Flow Characteristics: **Fast**  
Deposits: ☒ None ☐ Mud ☐ Sludge ☐ Debris ☐ Grease  
Silt Depth: (in.) Deposits Extent:  
Infiltration: **None** Pipe Seal Cond: **Sound**
